Manhole Inspection Summary

Manhole # S21MM_035MH

Insp Date: **7/2/07 9:20 AM**

Location Address: **BEHIND 2125 FULTON AVE**

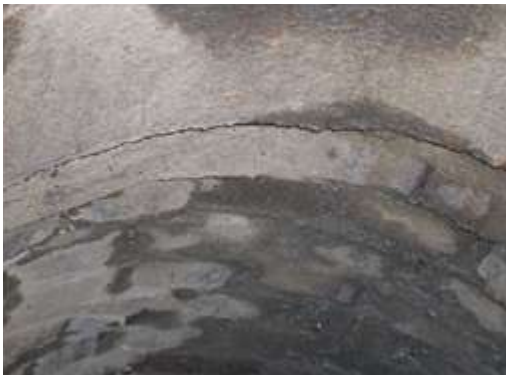
Defect 2

Infiltration: ☐ None ☒ **Joint** ☐ Cracks ☐ Mortar ☐ Roots ☐ Wall

INFILTRATION OF CORBEL

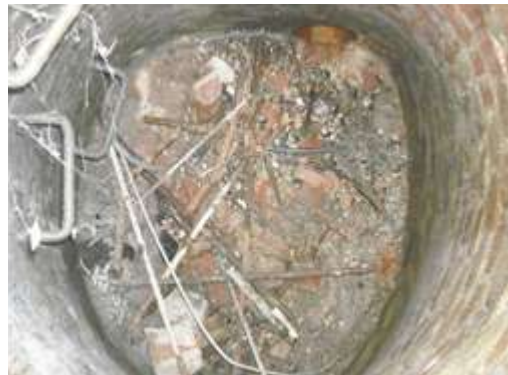
Defect 4

Comments **TOOK PHOTO SHOWING DEBRIS ON CHANNEL - REWORK COMPLETE 3-5-09**

Condition: ☐ Sound ☐ Cracked ☐ Root Intrusion ☐ Deteriorated ☐ Leaks ☒ **Debris**

DEBRIS IN CHANNEL

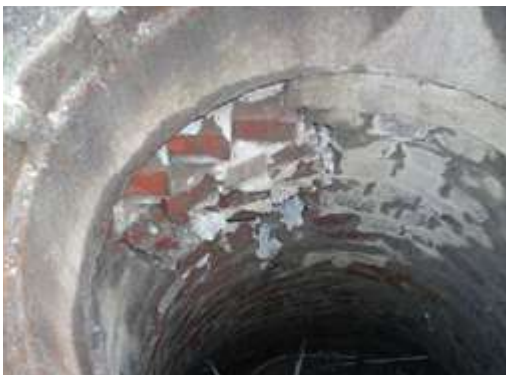
Defect 1

Condition: ☐ Sound ☐ Cracked ☐ Root Intrusion ☒ **Loose Brick** ☒ **Deteriorated**

VERY POOR CHIMNEY AND CORBEL

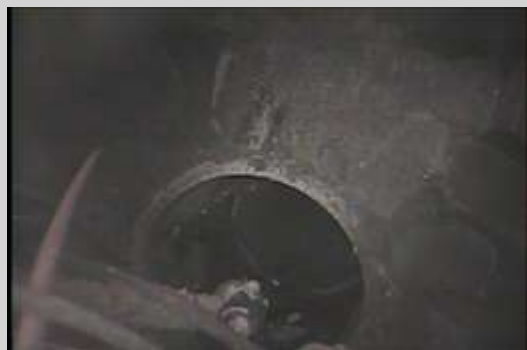
12 O'Clock Outflow

Deposits: ☐ None ☐ Mud ☐ Sludge ☒ **Debris** ☐ Grease

Silt Depth: **3** (in.) Deposits Extent: **Light**
